Upper Truckee River
SH+G 2003 Longitudinal Profile, Reaches 1 - 4

UTR Restoration Project, CDPR Reach
Restoration Feasibility Report

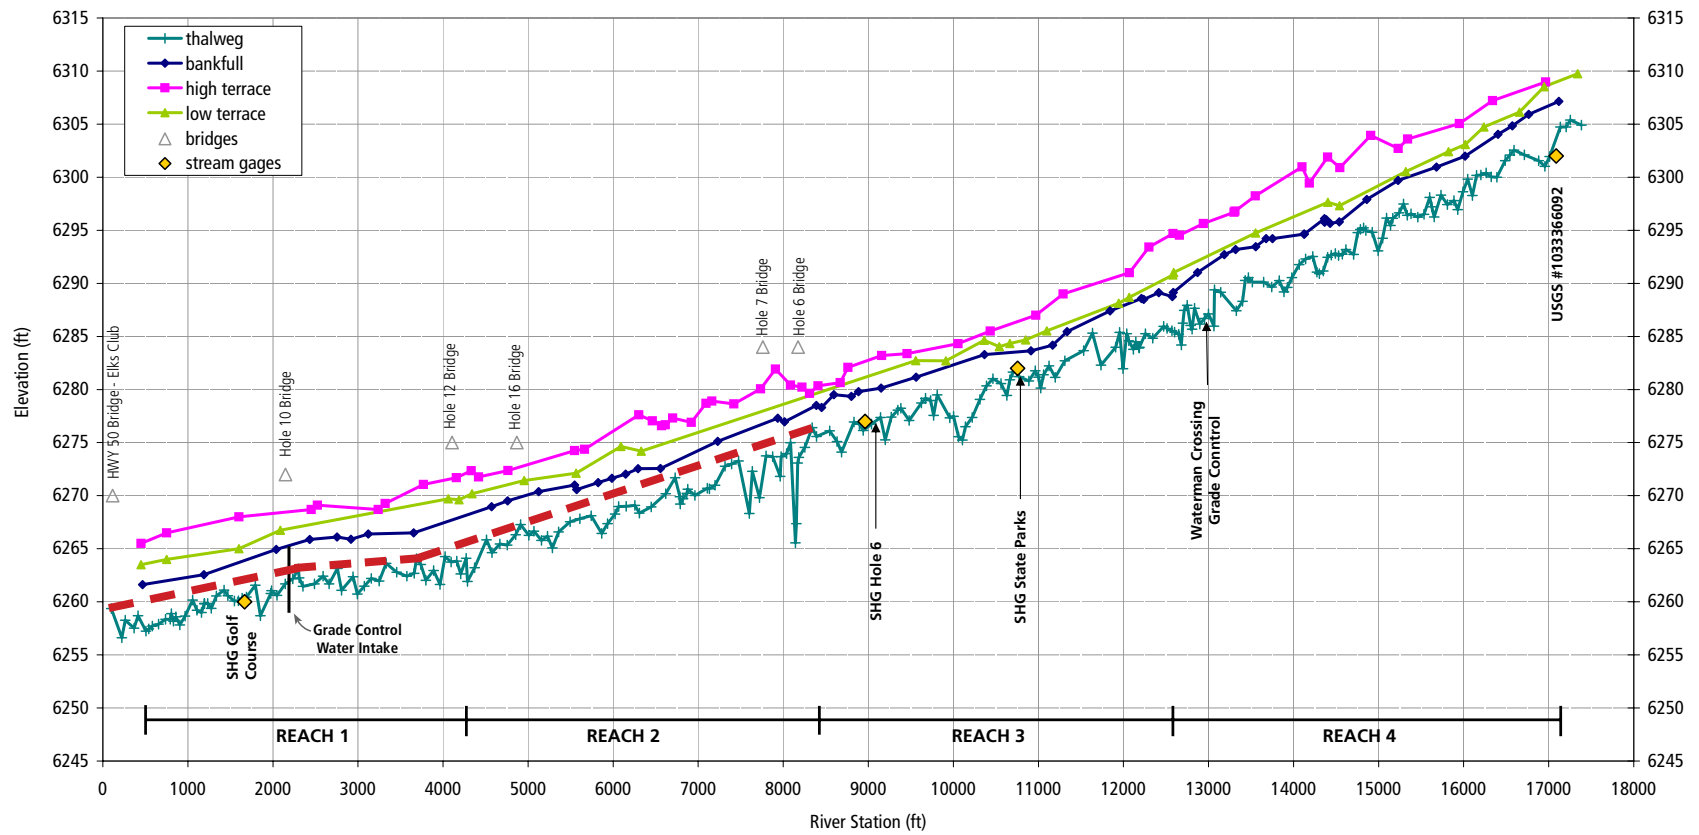
FIGURE 2.5: Longitudinal profile of Upper Truckee River from Elks Club Highway 50 crossing to Meyers Highway 50 crossing (Reaches 1-4). Bankfull, low terrace and high terrace features were also surveyed in the field.

Figure 13: Longitudinal Profile Longitudinal profile from SH+G (2004). Red dashed line represents average bed slope within the project area. Note high slope in upper portion of project area, and low slope in middle portion of project area.
