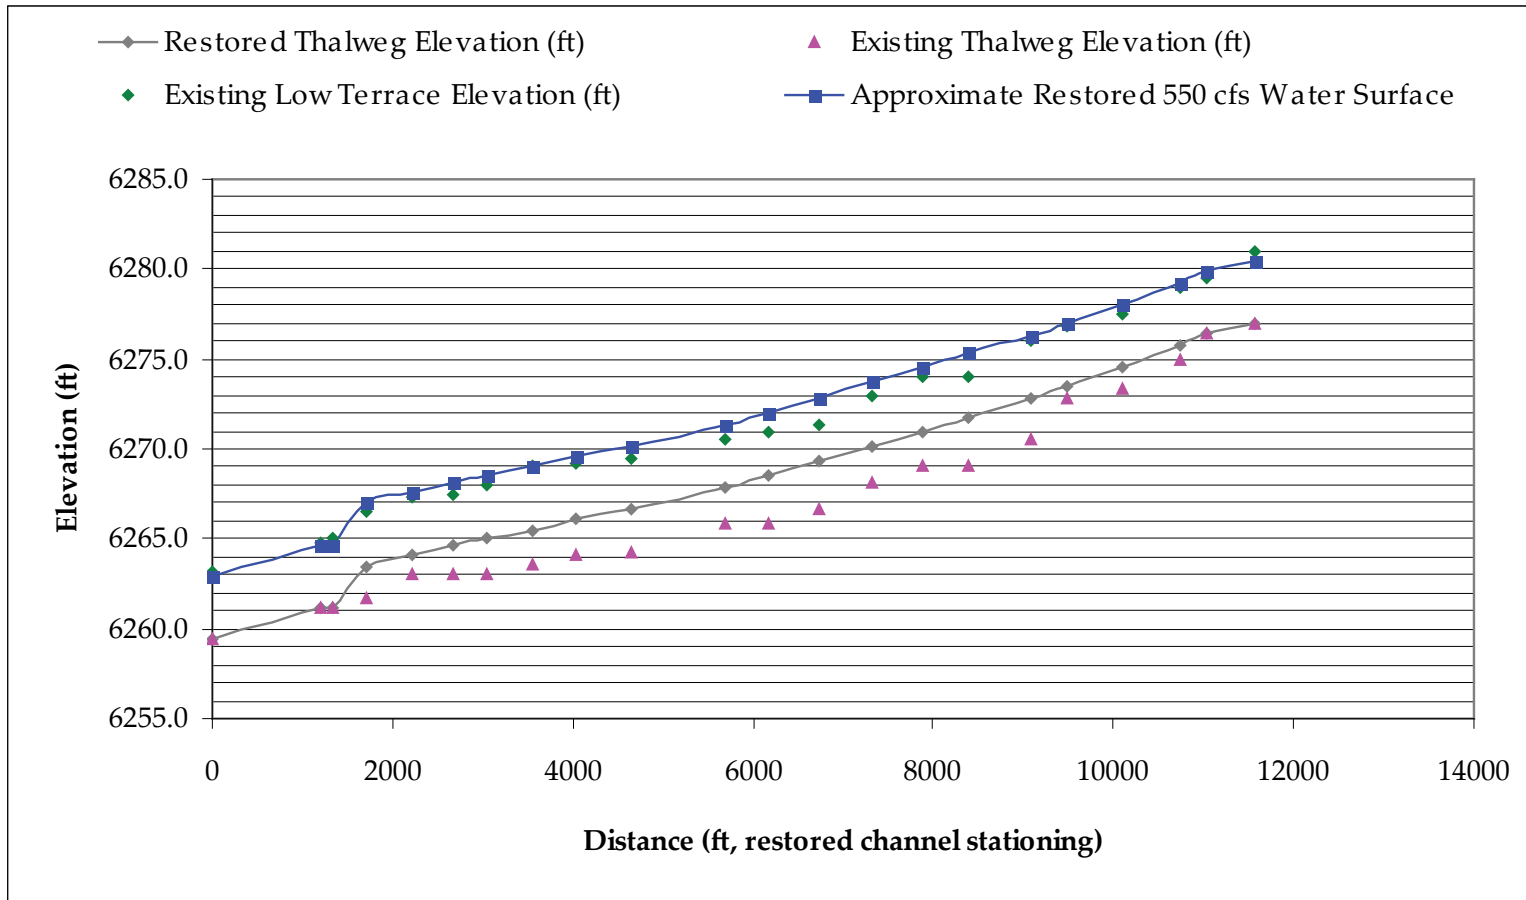
*Figure 18: Restored Profile* Stationing for this profile is the restored channel (see Figures 15-17). Data for existing thalweg elevation and low terrace elevation from SH+G (2004).
